ARMSTRONG

AL/CF-TR-1993-0095

ASSESSMENT OF INTERIOR MODIFICATIONS
IN C-130 AND C-141 AIRCRAFT FOR
NIGHT VISION GOGGLE OPERATIONS (U)

FINAL REPORT FOR THE PERIOD MARCH 1992 - DECEMBER 1992

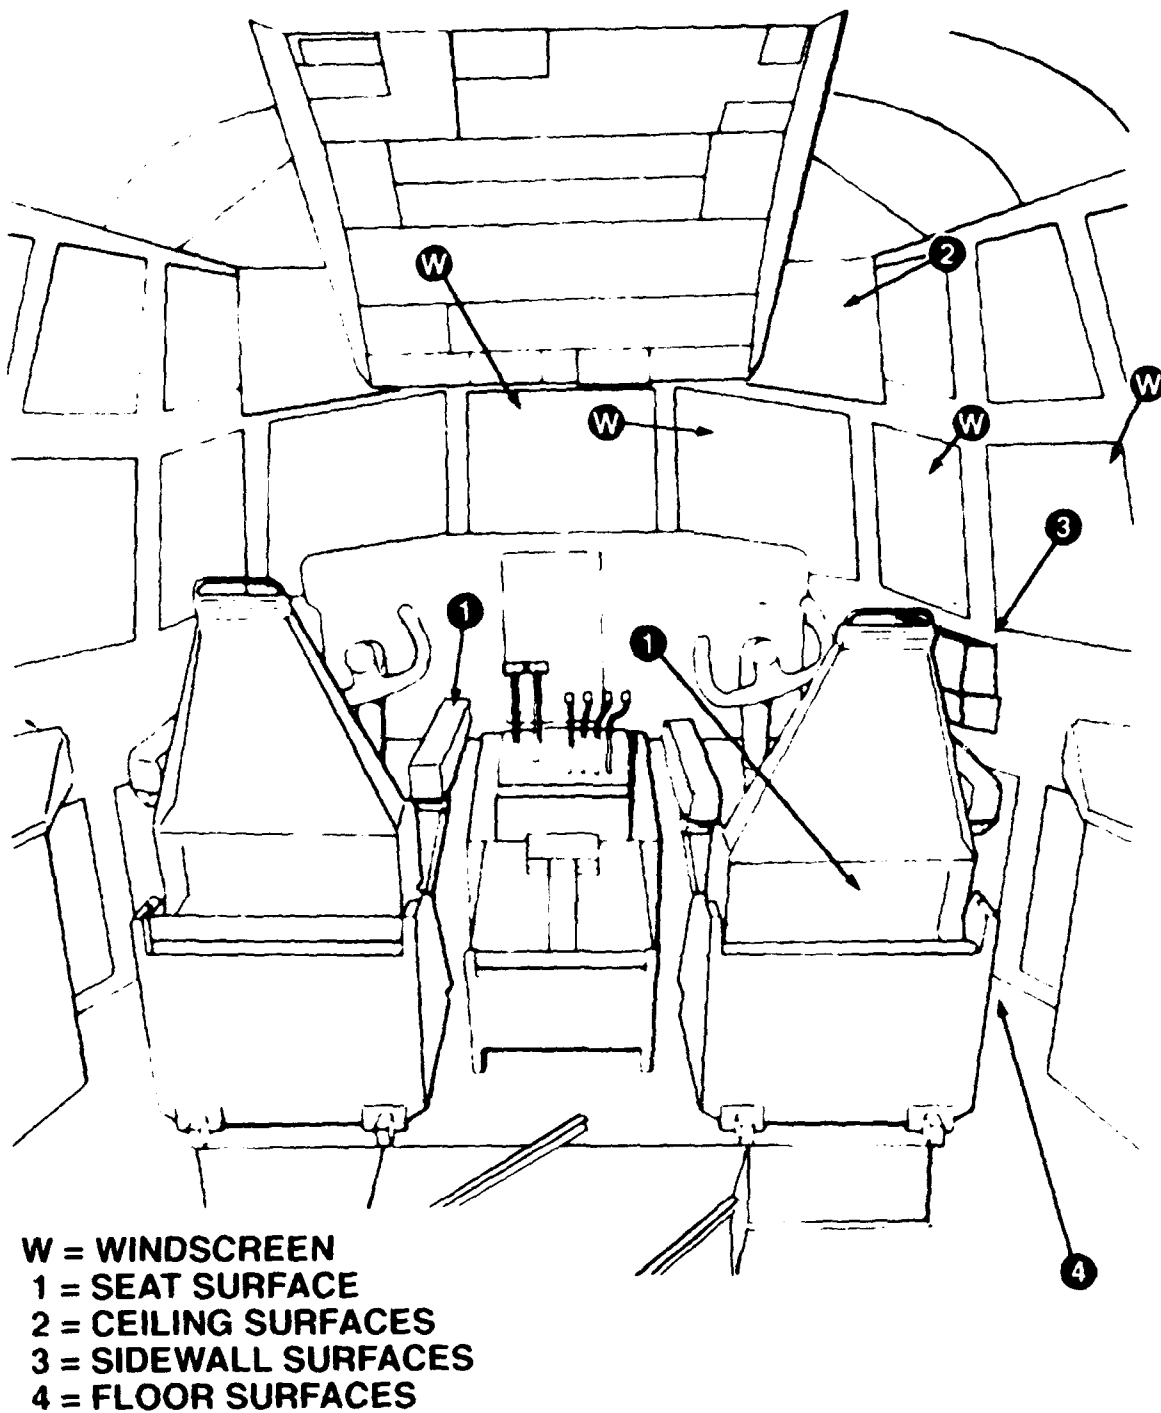
Figure 1: Radiance Measurement Locations on the C-130 Flight Deck.

were not calculated for these windscreen locations. These NVIS radiances were interpreted in terms of the guidelines in MIL-STD-85762A. The measurement locations for the C-130H and C-141B flight decks are shown in Figures 1 and 2, respectively.

The shiny metal floor material found in the modified C-130 cockpit at the pilot and copilot stations is extremely reflective and produced very intense specular reflections which were too bright for the NVG-103 to measure. These specular reflections reach the windscreens, particularly in the swing window area. The shiny handgrips located above the forward windscreens also tend to produce reflections in the windscreen. The dark blue flooring which is now used in both aircraft types is significantly less reflective than the original floor materials.

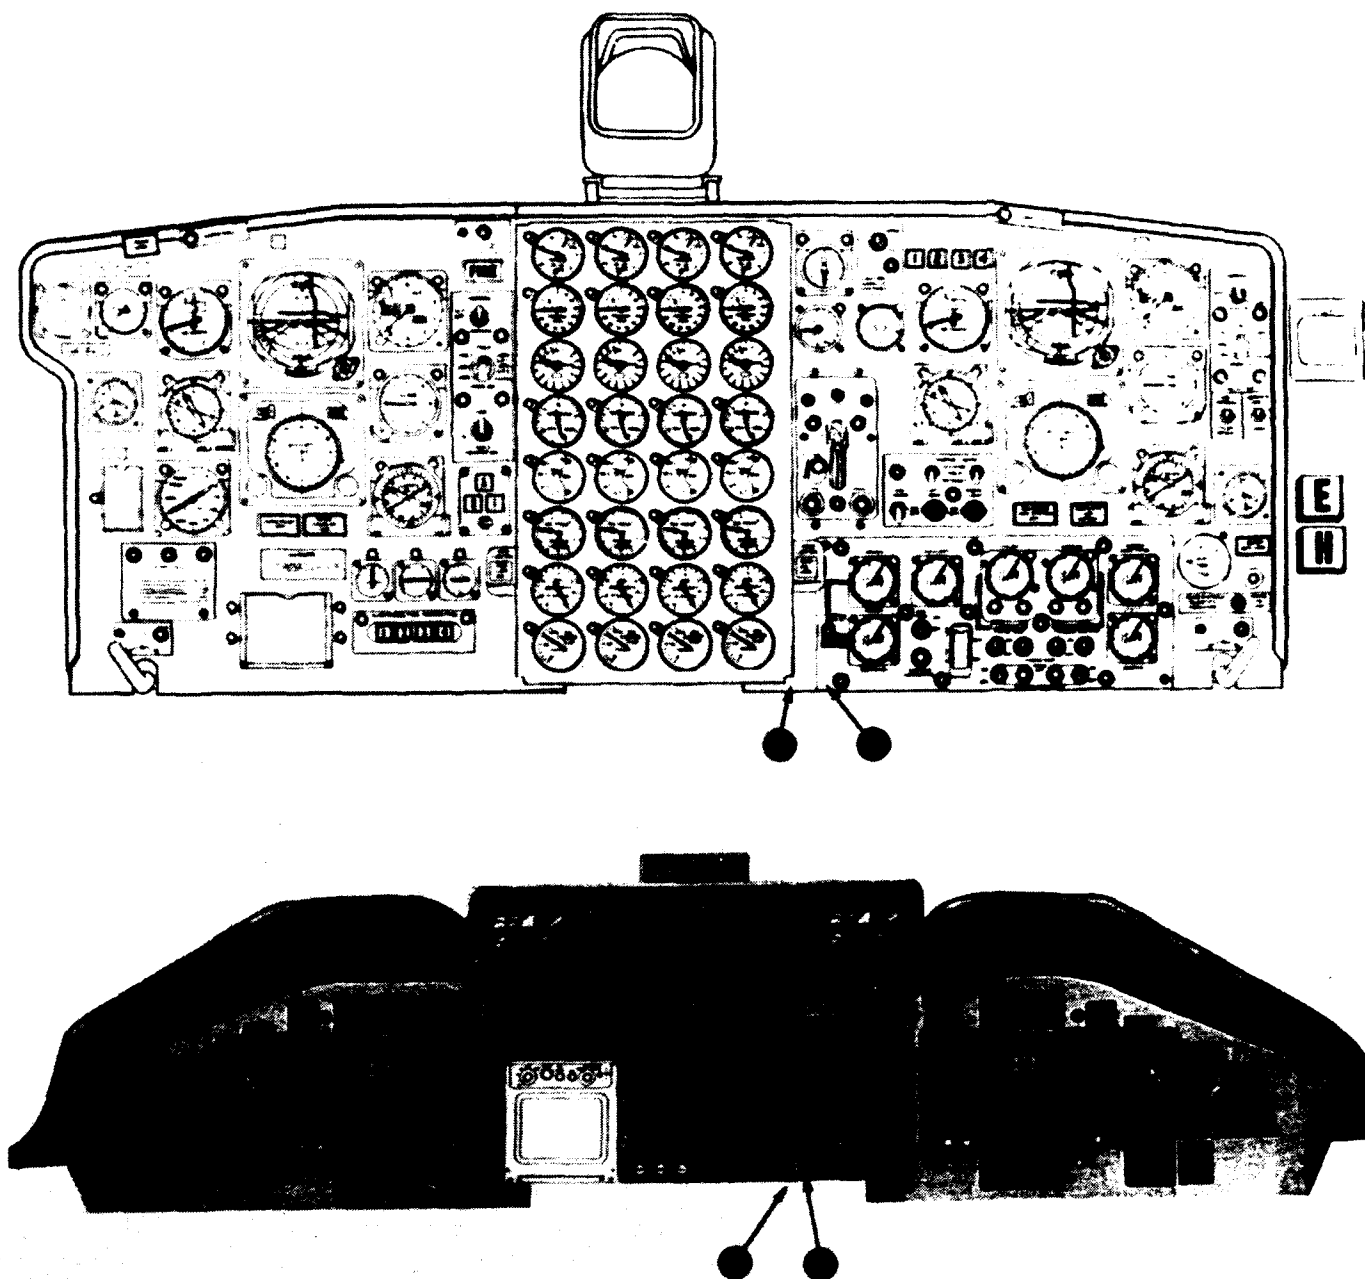
Figure 3: Reference Measurement Locations in the C-130 (top) and C-141 (bottom) Cockpit

Measurements were made of one modified and one unmodified version of the C-130H and the C-141B aircraft (a total of four aircraft). Results from the unmodified aircraft were used as a baseline for comparison with the modified versions. To ensure consistent initial overall cockpit NVIS radiance levels between modified and unmodified versions of the same aircraft type for measurement repeatability, a black surface and a gray surface on the instrument panel were chosen as reference points and measured. These particular locations were chosen because the colors and finishes were the same in all four aircraft evaluated. Figure 3 shows the approximate location of the reference points for the C-130 and C-141 cockpits.
